**Flood Control Project Maintenance
Levee Inspections**

2013 Channel Summary Report

San Joaquin County Flood Control and Water Conservation District

Duck Creek Diversion Channel

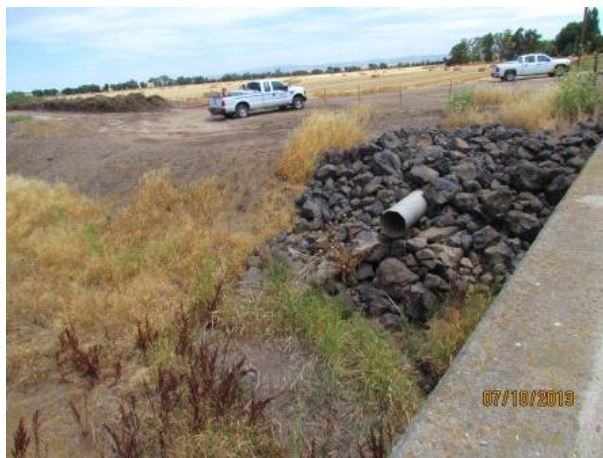
pkazi_c_20130715_085.JPG

View of the revetments on the left bank of the channel looking upstream.

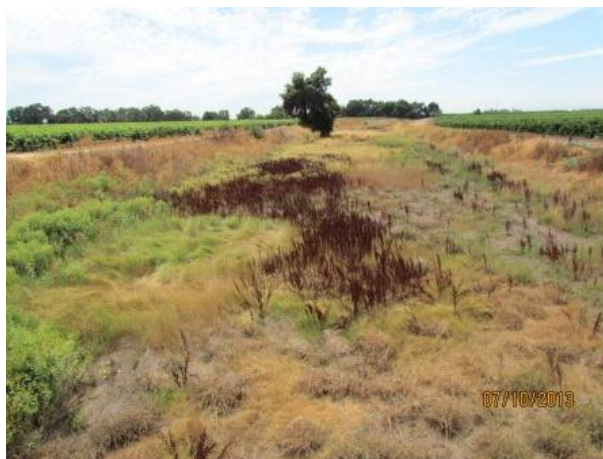
pkazi_c_20130715_086.JPG

View of the vegetation growth on downstream of the channel.

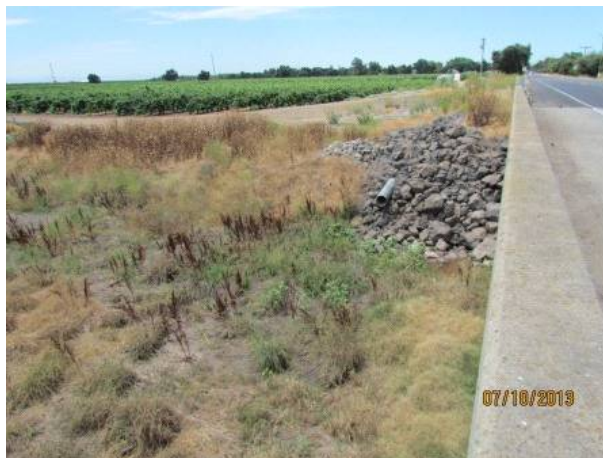
pkazi_c_20130715_087.JPG

View of the revetments on the right bank of the channel looking downstream.

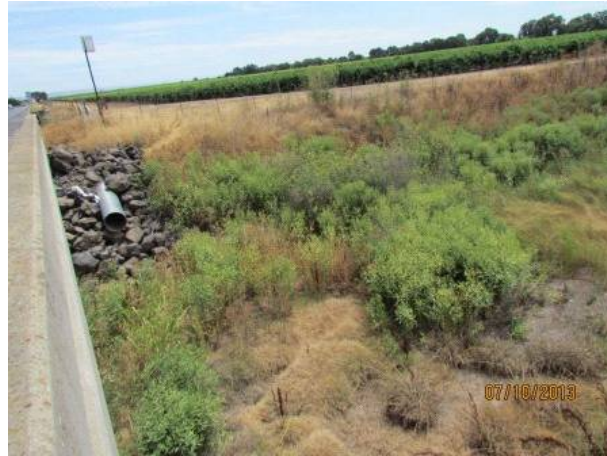
pkazi_c_20130715_088.JPG

View of the revetments on the left bank of the channel looking downstream.

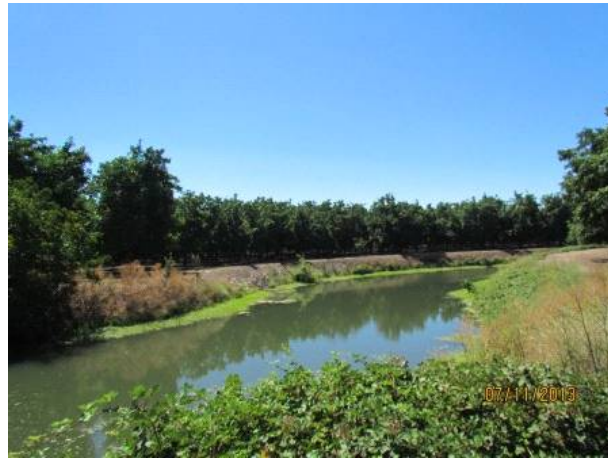
pkazi_c_20130725_101.JPG

View of vegetation on the upstream limit of North Little John.

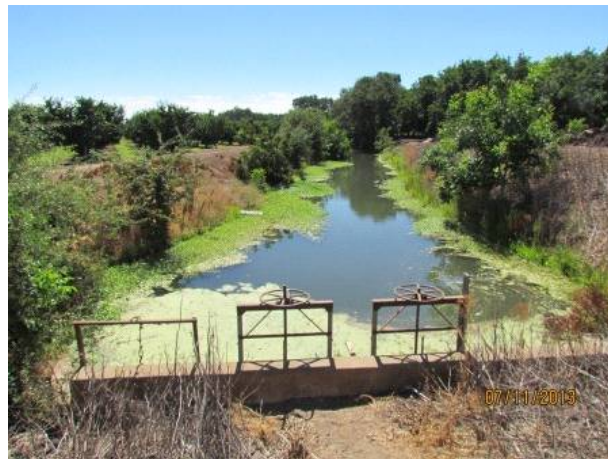
pkazi_c_20130725_102.JPG

View of vegetation looking upstream of the channel.

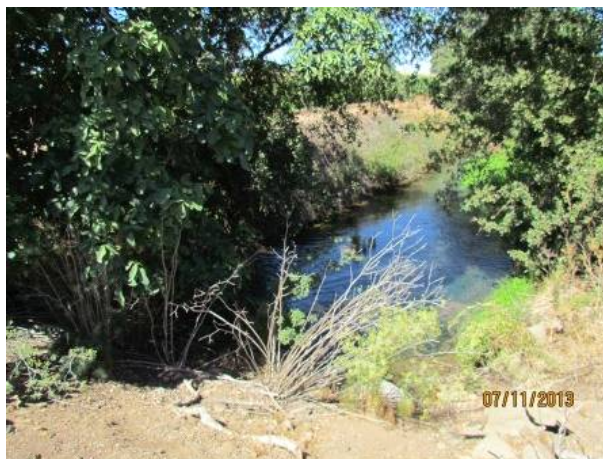
pkazi_c_20130725_105.JPG

View of the vegetation on the downstream of the channel.

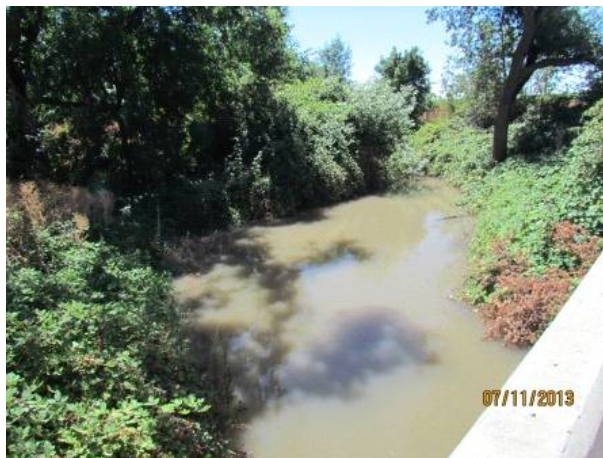
pkazi_c_20130726_106.JPG

View of the tree branches that may impede the flow of the channel looking upstream.

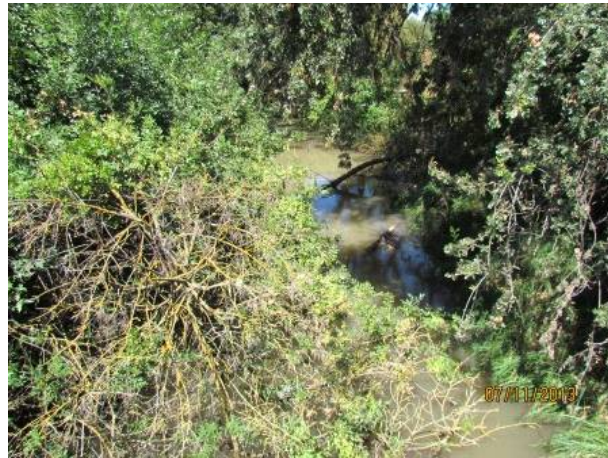
pkazi_c_20130726_107.JPG

View of the vegetation and tree logs in the channel looking downstream.

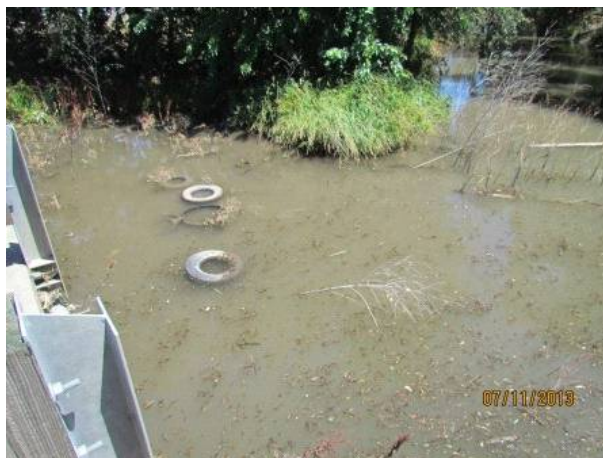
pkazi_c_20130802_115.JPG

View of the debris in the channel looking upstream.

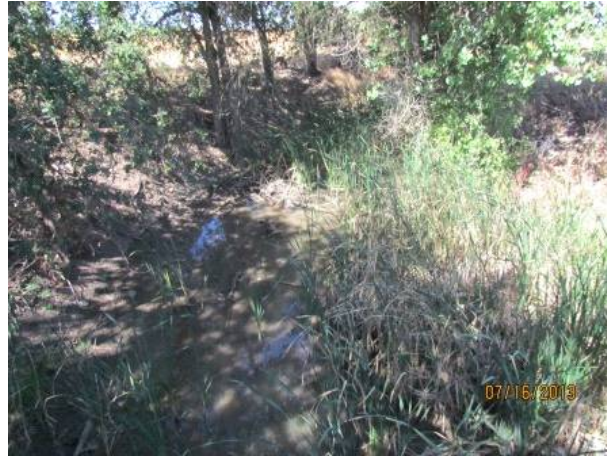
Levee Mile Report Line	42
Start Levee Mile	0.00
End Levee Mile	0.00
Location	
Category	Channels
Item	Vegetation & Obstructions
View of the vegetation growth on the downstream end of the channel.	
pkazi_c_20130805_128.JPG

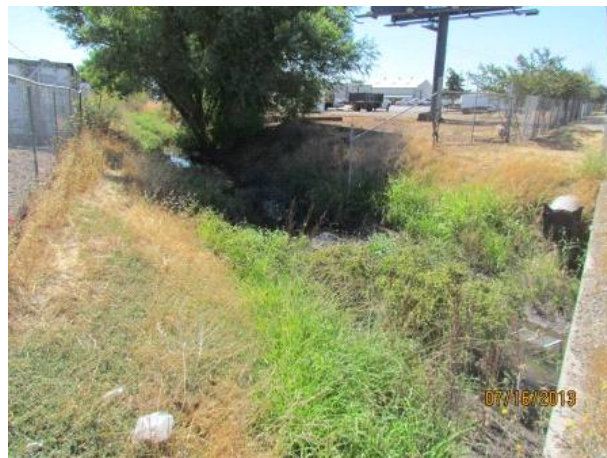
Levee Mile Report Line	47
Start Levee Mile	0.00
End Levee Mile	0.00
Location	
Category	Channels
Item	Vegetation & Obstructions
View of the vegetation on the channel looking upstream.	
pkazi_c_20130805_130.JPG

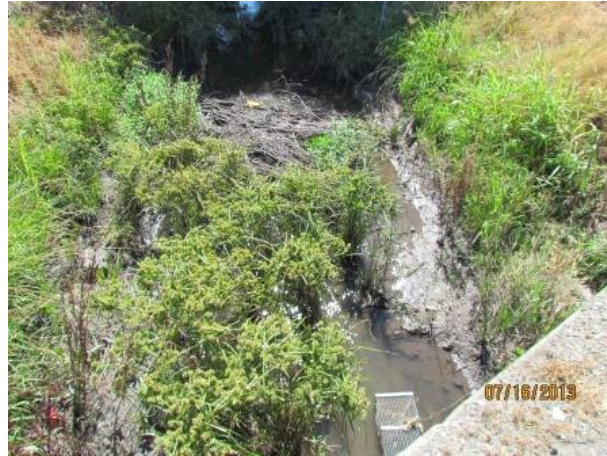
pkazi_c_20130805_131.JPG

View of sedimentation on the upstream of the channel.

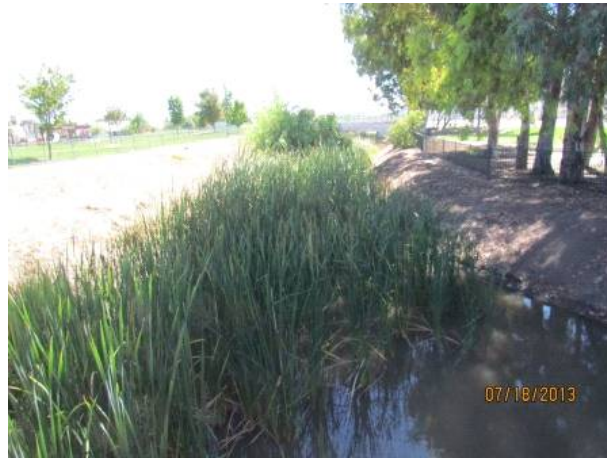
pkazi_c_20130805_147.JPG

View of the vegetation in the channel looking upstream.

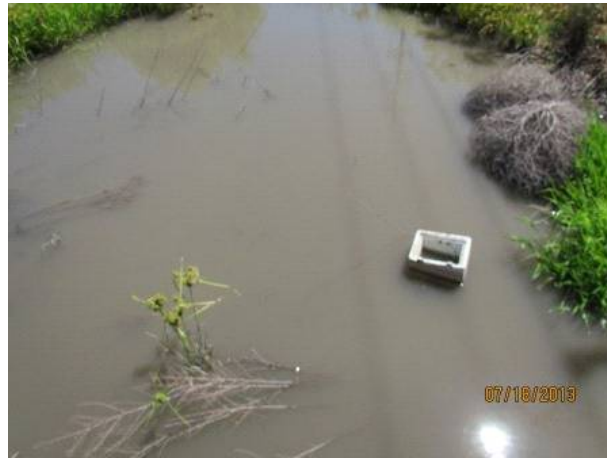
pkazi_c_20130805_149.JPG

View of the encroachment on the channel looking upstream.

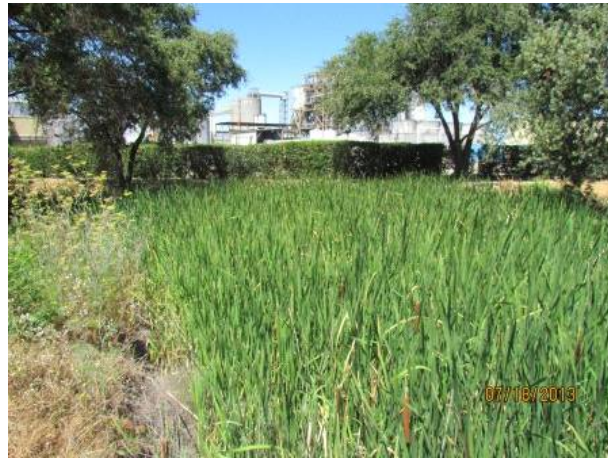
pkazi_c_20130805_151.JPG

View of the vegetation growth on the channel looking downstream.

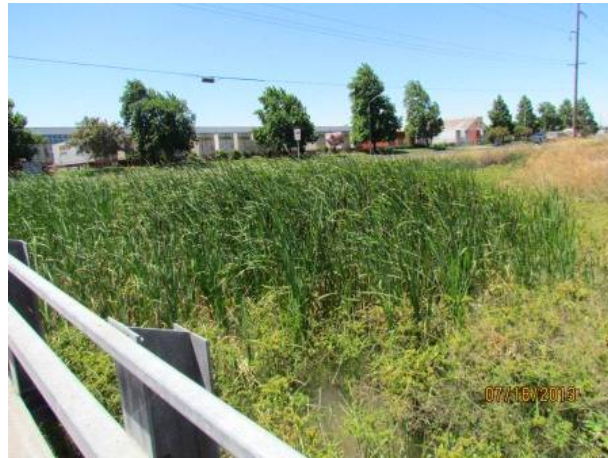
pkazi_c_20130805_153.JPG

View of the vegetation growth on the downstream end of the channel.

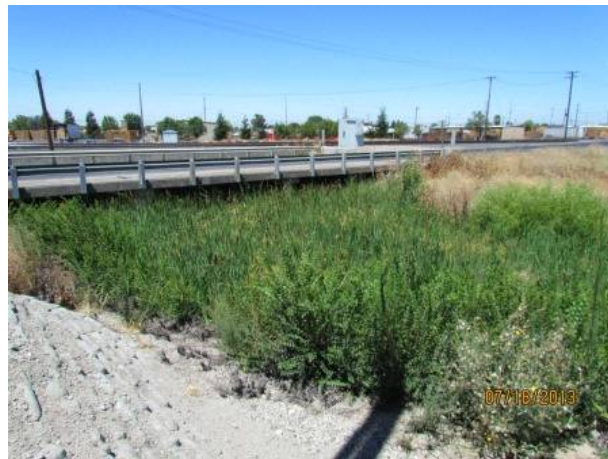
pkazi_c_20130805_155.JPG

View of the vegetation growth at upstream end of the channel.

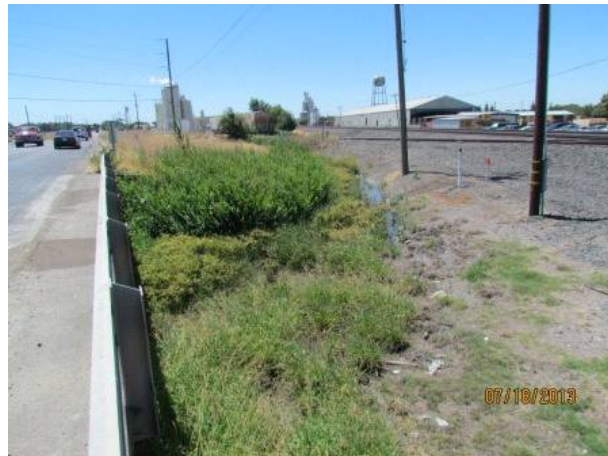
pkazi_c_20130805_156.JPG

View of the vegetation looking downstream of the channel.

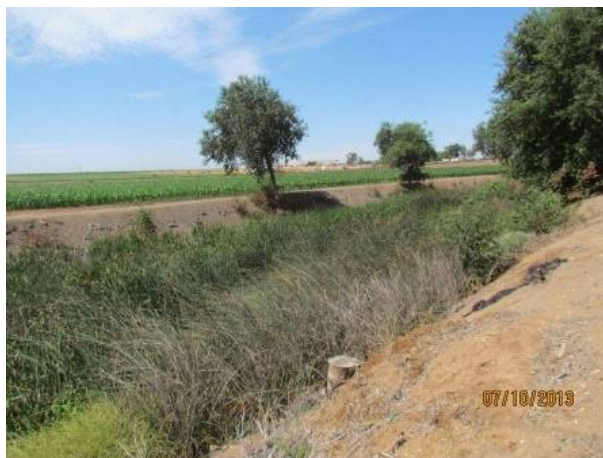
pkazi_c_20130715_075.JPG

View of the vegetation which could impede the flow of the channel looking downstream.

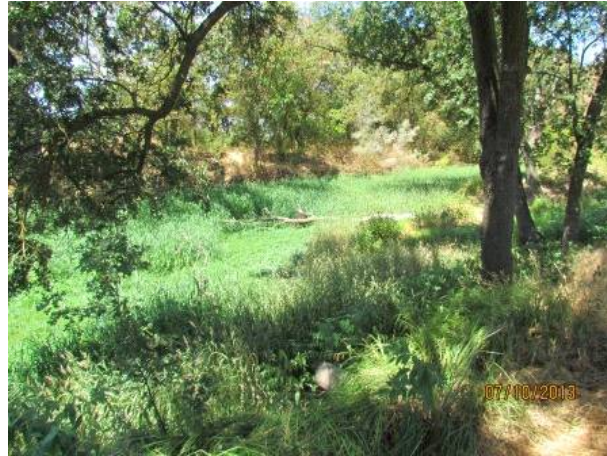
pkazi_c_20130724_093.JPG

View of tree trunks on the channel looking downstream.

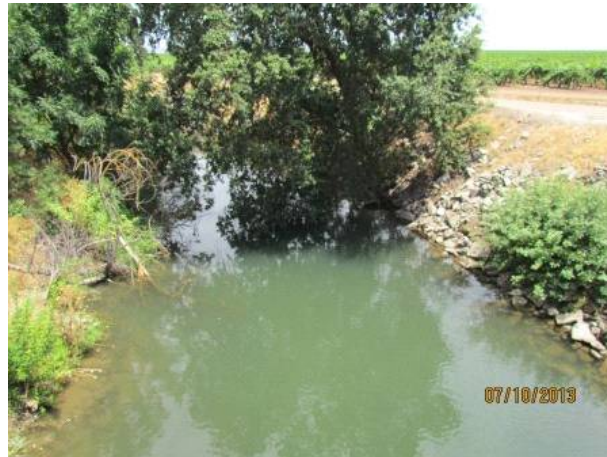
pkazi_c_20130724_094.JPG

Tree branches may impede the flow of the channel looking upstream.

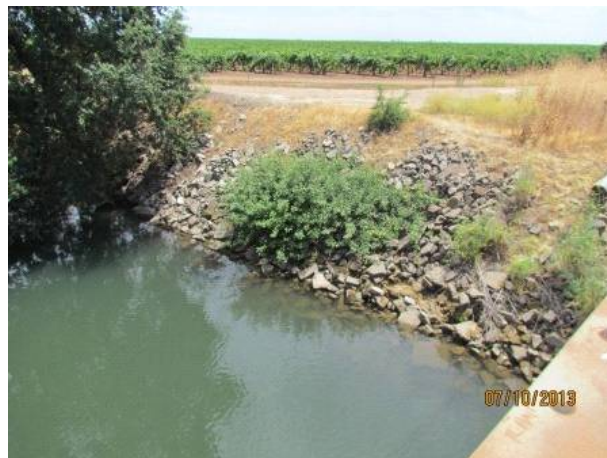
pkazi_c_20130724_095.JPG

Existing revetments are properly maintained looking upstream of the channel.

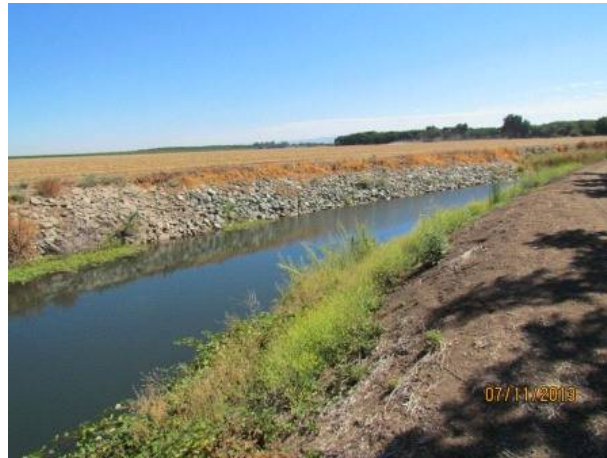
Levee Mile Report Line	30
Start Levee Mile	0.00
End Levee Mile	0.00
Location	
Category	Channels
Item	Revetments
The revetments on the channel bank were properly maintained. The picture was taken looking upstream.	
pkazi_c_20130724_099.JPG

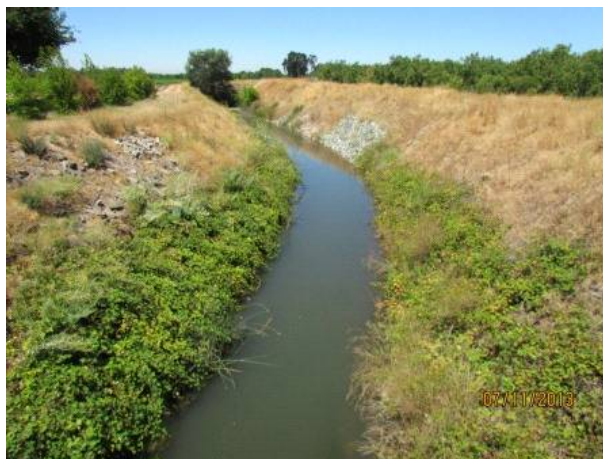
pkazi_c_20130726_110.JPG

View of the channel looking downstream.

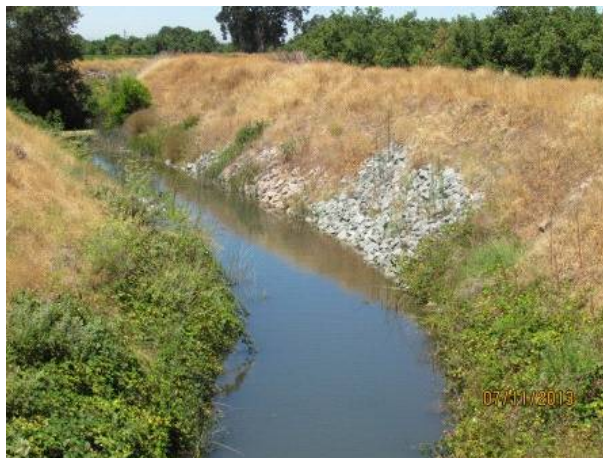
pkazi_c_20130726_111.JPG

View of the existing revetments looking downstream.

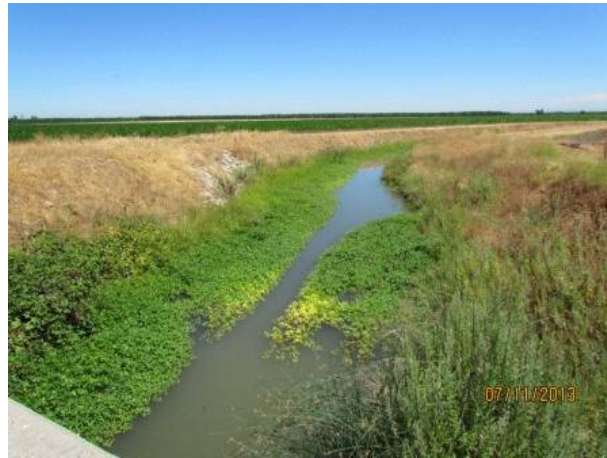
pkazi_c_20130802_112.JPG

View of the channel looking upstream.

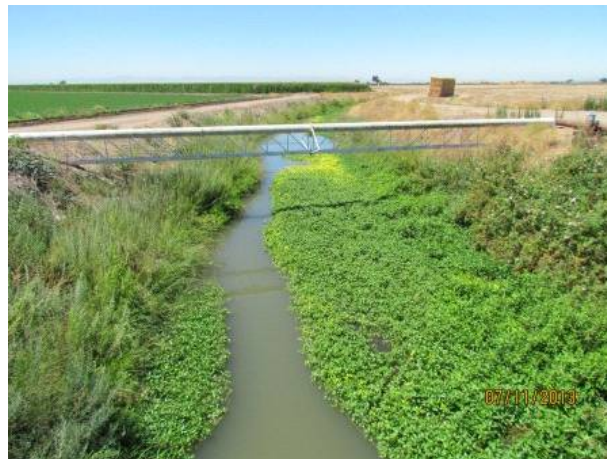
pkazi_c_20130802_113.JPG

View of the channel looking downstream.

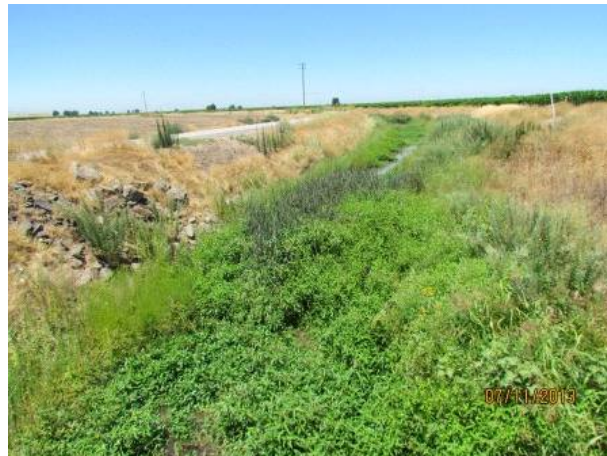
pkazi_c_20130802_121.JPG

View of the vegetation on the upstream of the channel.

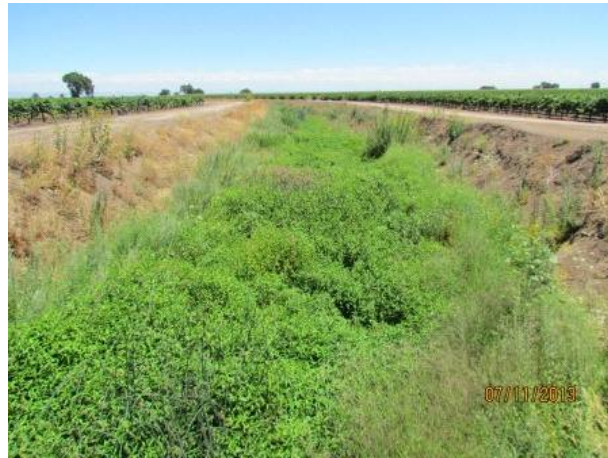
pkazi_c_20130802_122.JPG

View of the vegetation in the channel looking downstream.

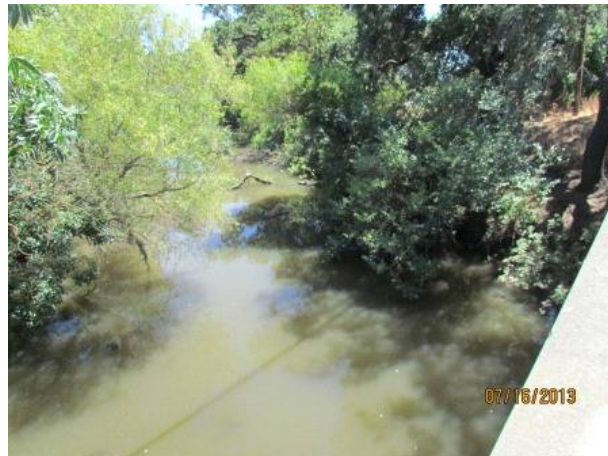
pkazi_c_20130805_144.JPG

View of the channel looking upstream.

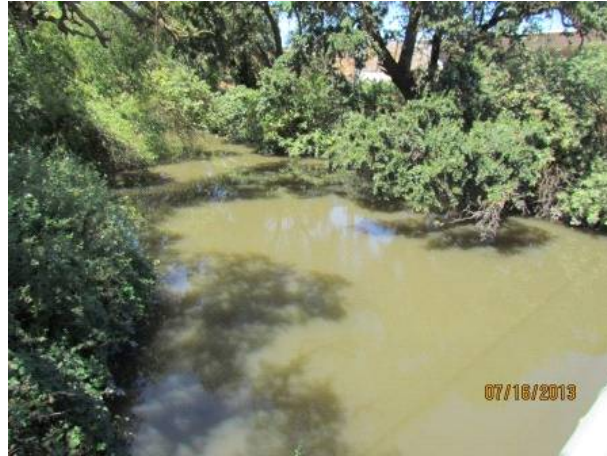
pkazi_c_20130805_145.JPG

View of the channel looking downstream.

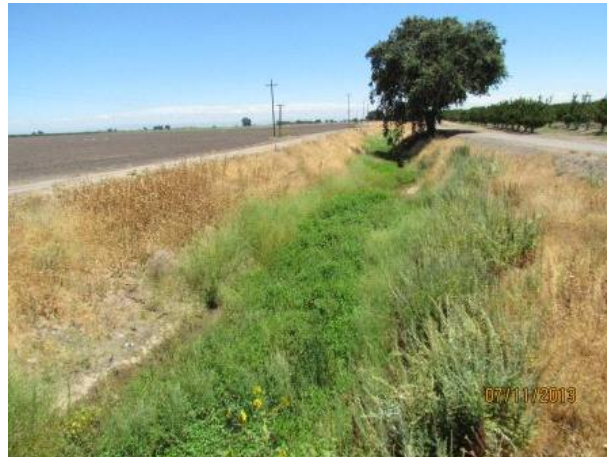
pkazi_c_20130802_124.JPG

View of vegetation in the upstream end of the channel.

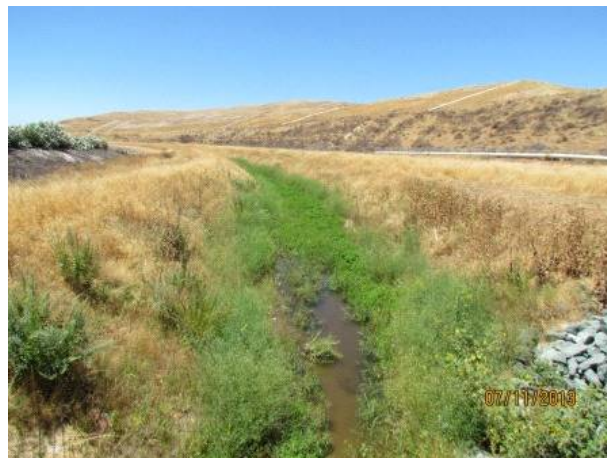
pkazi_c_20130802_125.JPG

This picture shows the vegetation on the downstream of the channel.

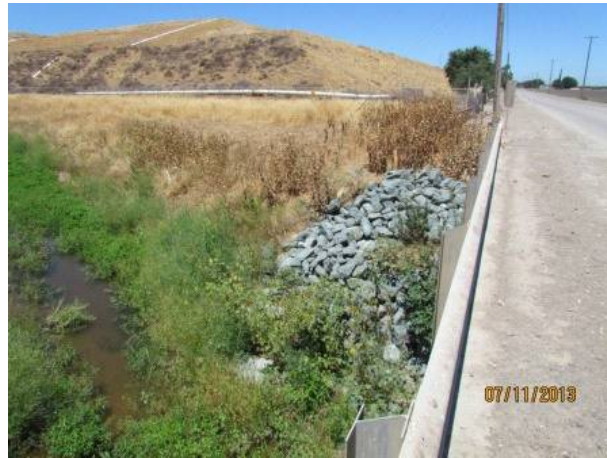
pkazi_c_20130802_126.JPG

View of the revetments on the downstream of the channel.

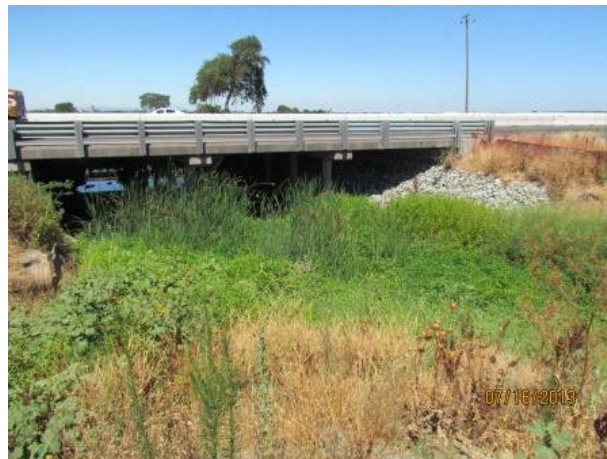
pkazi_c_20130805_134.JPG

View of vegetation growth on the upstream end of channel

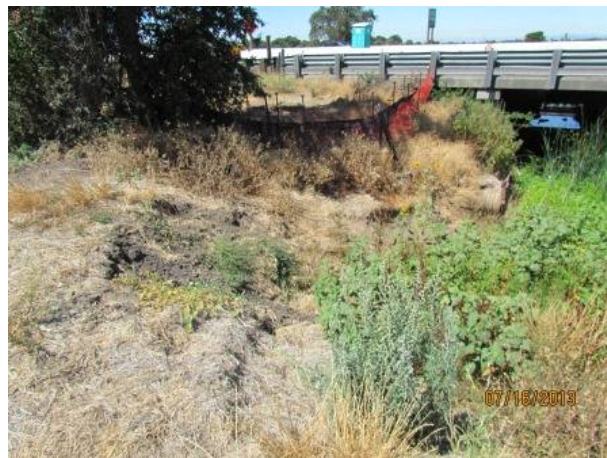
pkazi_c_20130805_135.JPG

View of the erosion on the channel bank looking upstream.

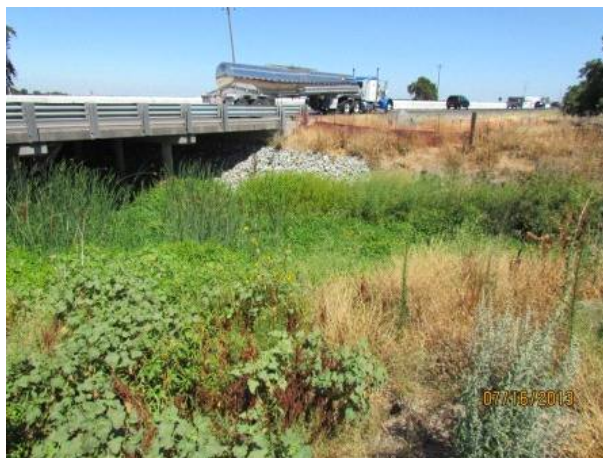
pkazi_c_20130805_136.JPG

View of the existing revetments on the upstream end of the channel.

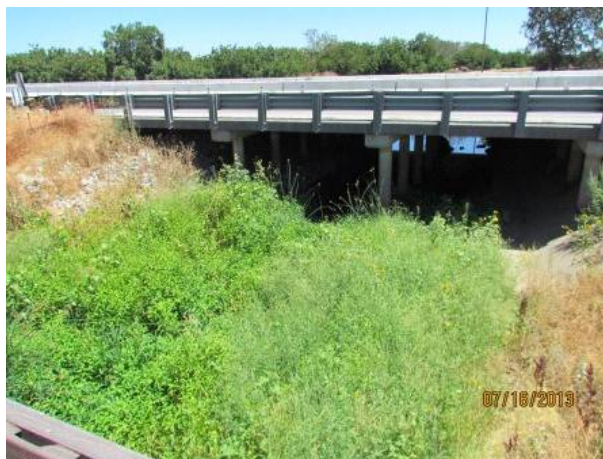
pkazi_c_20130805_137.JPG

View of the vegetation looking downstream of the channel.

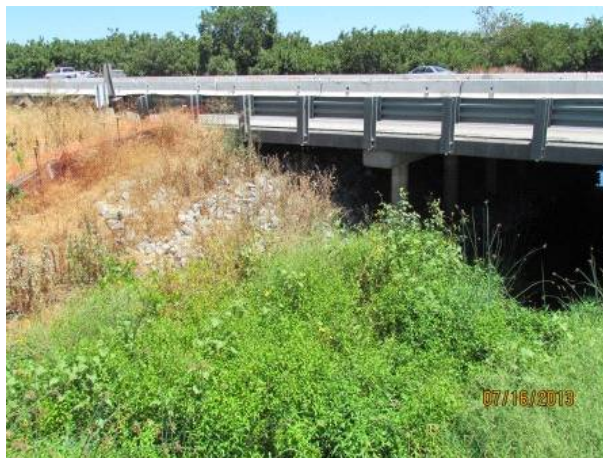
pkazi_c_20130805_138.JPG

View of the existing revetments on the downstream end of the channel.

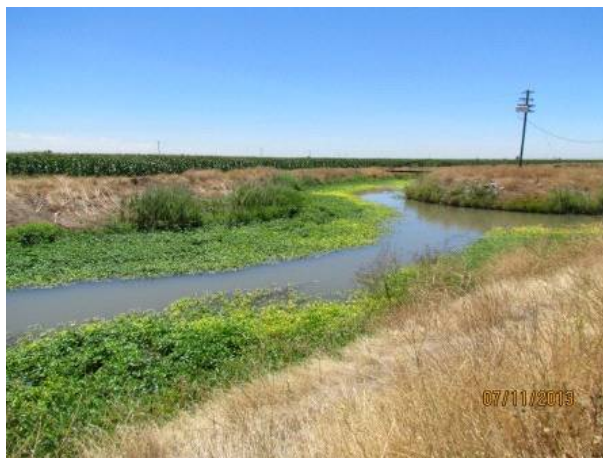
pkazi_c_20130802_117.JPG

View of the downstream of the channel.

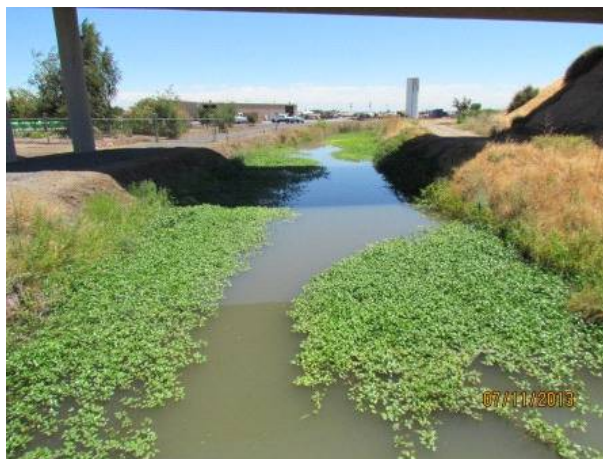
pkazi_c_20130802_118.JPG

View of the vegetation upstream end of the channel.

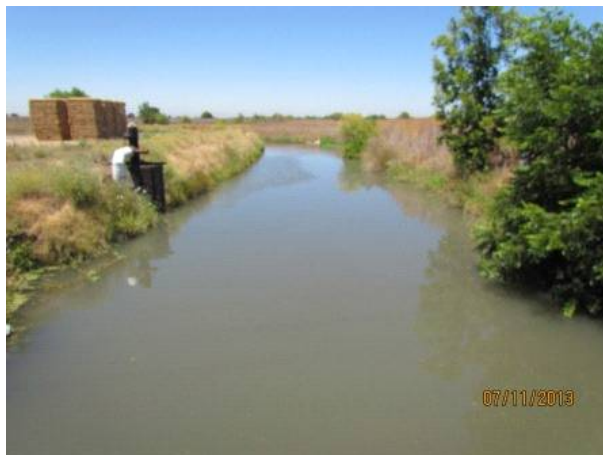
pkazi_c_20130802_119.JPG

View of the channel looking downstream.

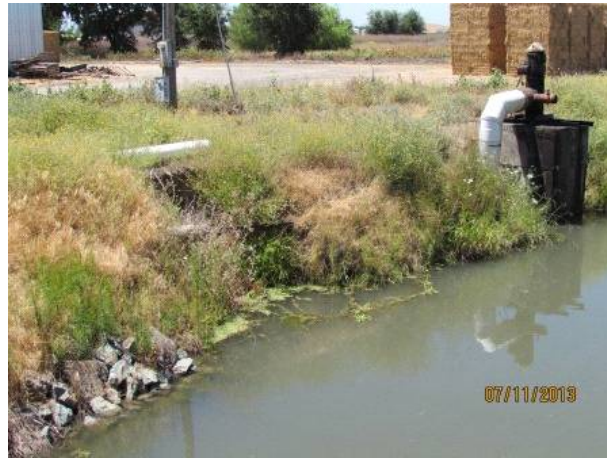
pkazi_c_20130802_120.JPG

View of bank erosion on the downstream of the channel.

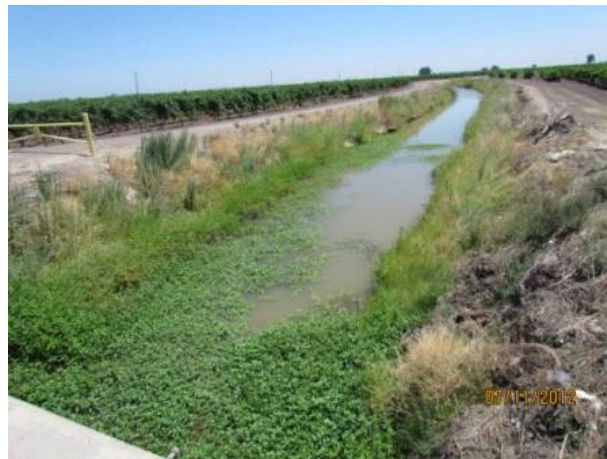
pkazi_c_20130618_069.jpg

This picture shows the vegetation appears to obstructing the flow at the upstream of the channel.

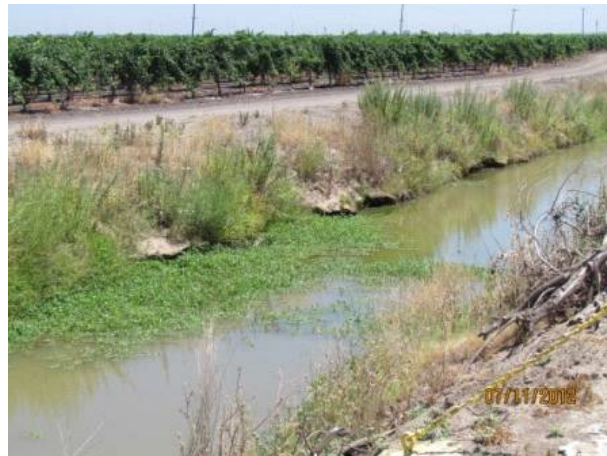
pkazi_c_20130618_070.jpg

The picture shows the occurrence of erosion at the upstream of the channel.

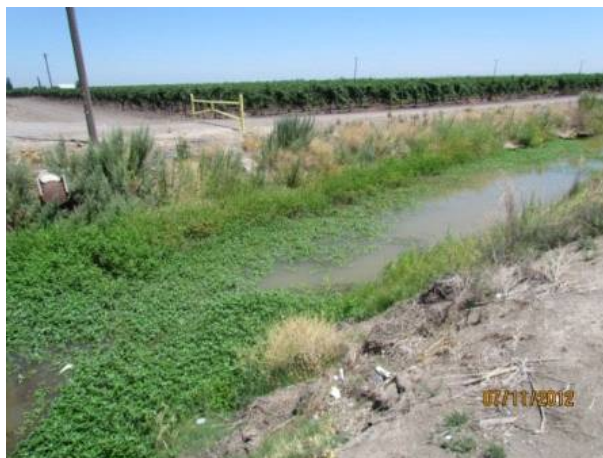
pkazi_c_20130618_071.jpg

This picture shows the encroachment at the upstream of the channel.

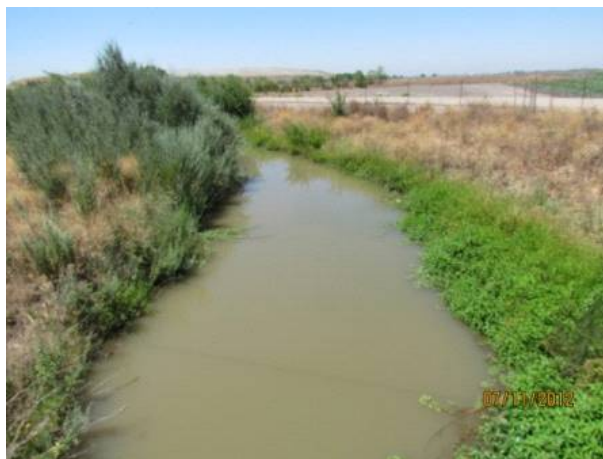
pkazi_c_20130618_072.jpg

View of the downstream of the channel.

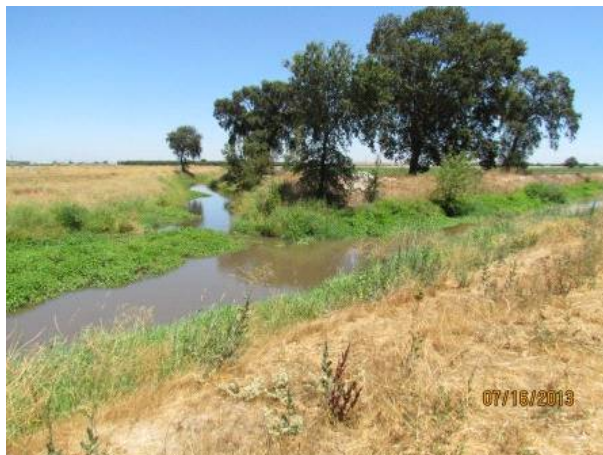
pkazi_c_20130805_142.JPG

View of upstream of the channel.

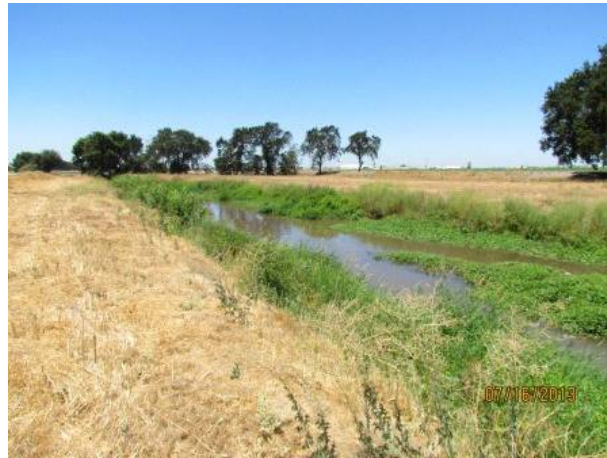
pkazi_c_20130805_143.JPG

View of the downstream of the channel.

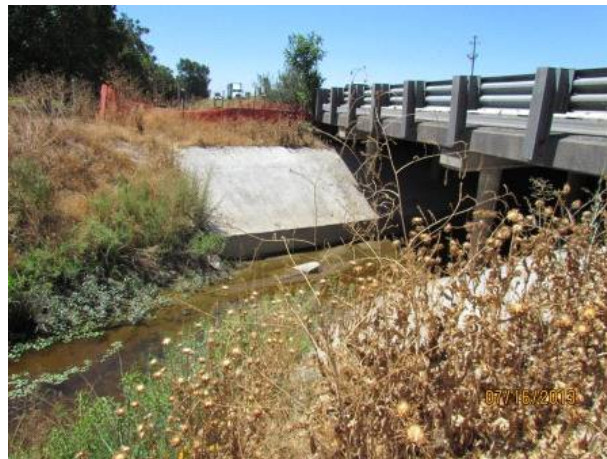
pkazi_c_20130805_139.JPG

View of the channel looking upstream.

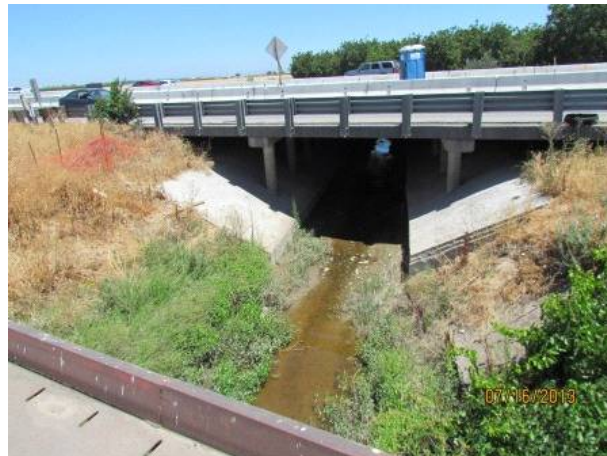
pkazi_c_20130805_140.JPG

View of the channel looking downstream.

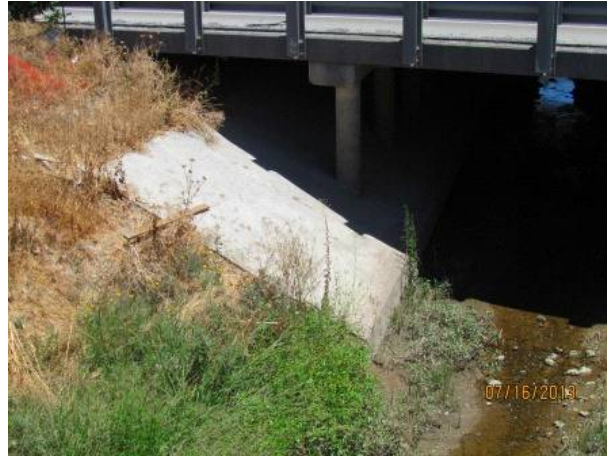
pkazi_c_20130805_141.JPG

View of the revetments on the downstream end of the channel.
